WRDC-TR-89-4138

## X-RAY COMPUTED TOMOGRAPHY OF CASTINGS

March 1990

MATERIALS LABORATORY  
WRIGHT RESEARCH AND DEVELOPMENT CENTER  
AIR FORCE SYSTEMS COMMAND  
WRIGHT-PATTERSON AIR FORCE BASE, OH 45433-6533

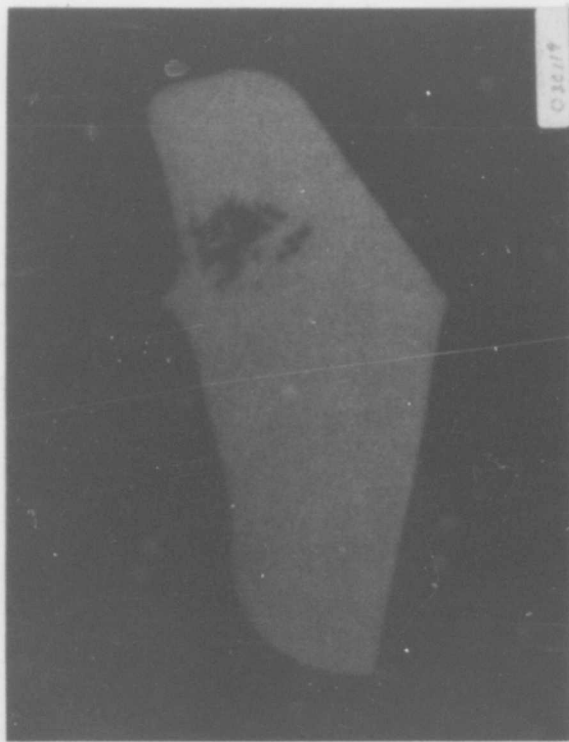
(a) CT1

(b) CT2

(c) CT3

(d) Medical CT Scan (See Figure 3.1-2d.  
CT3 Slice Location)

Figure 3.1-3 CT scans of PID #119, filamentary shrinkage

A small coupon, PID #119, containing multiple string like or filamentary low density indication (LDI) areas caused by shrinkage during solidification of the casting was excised from an aluminum aircraft housing. Figures 3.1-2(a) and (b) are photographs of the full-sized and the excised part. Figure 3.1-2(c) shows two film RT views and Figure 3.1-2(d) shows a DR from System J. Figure 3.1-3(a) through (c) shows three CT slices of the coupon from System J taken at the slice planes indicated in the DR of Figure 3.1-2(d). The filamentary shrinkage area is seen in cross section as string-like low density groupings ranging from 0.25 to 2.0 mm (0.01 to 0.08 inches) in diameter. Figure 3.1-3(d) shows a CT image taken on system K at approximately location CT3. The contrast level setting used in the reproduced image is such that the defect area is observed as an enlarged hole. This system can readily detect the defect feature but does not resolve the detail.

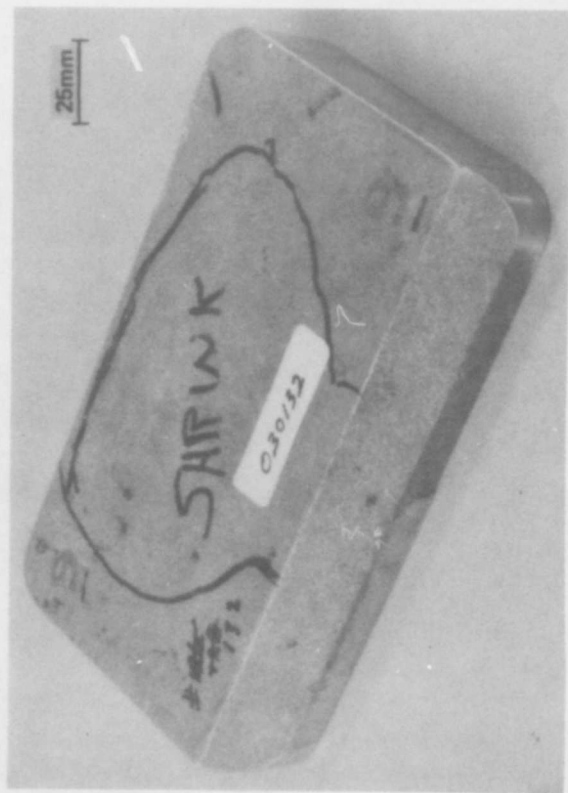
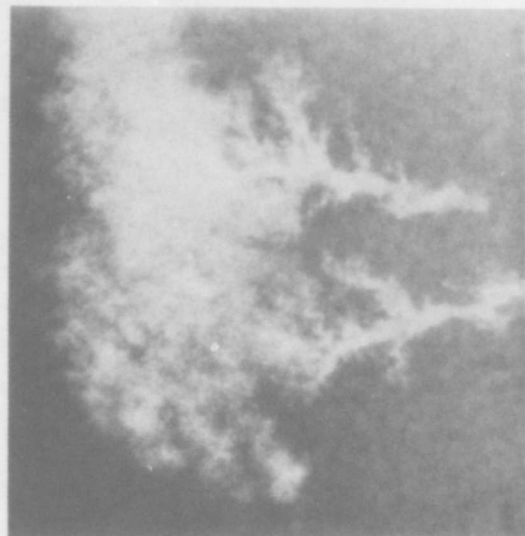
(a) Photo of PID No 132

(b) X-Ray

(c) System I DR

(d) CT Scan as Indicated

(e) System I Coplaner 15 mm Thick CT Scan

Figure 3.1-4 PID #132, dendritic (feather ) shrinkage

An example of large shrinkage was found in a sample aluminum casting. The area was excised to form a 170 x 100 x 25 mm (6.7 x 3.9 x 1 inch) slab-like section (PID #132), as shown in Figure 3.1-4(a). The flaws, assigned ASTM F6 - F8 shrinkage, consist of two dendritic (or feathery) shrinkage patterns as shown in the radiograph in Figure 3.1-4 (b). A DR taken on System I is shown in Figure 3.1-4(c). A CT scan normal to the surface, taken on System B, is shown in Figure 3.1-4(d). The CT slice was effective in providing flaw depth and distribution information which is unavailable in the RT or DR images.

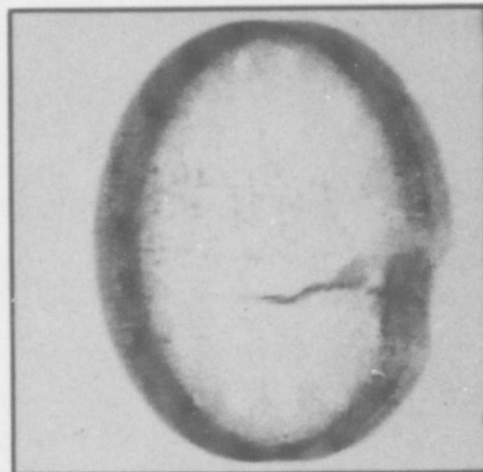
(b) Rotated 210°

Figure 3.4-3 Two selected 3D views of PID #120 (crack)

Figure 3.4-1 is a 3D image of PID #119. The data was obtained from 200 slices taken at 410 kV with 0.125 mm (0.005 inch) slice thickness on System J. Figure 3.4-2 is a 3D image of the casting holes, PID #118A. The data was taken at 350 kV with 1.5 mm (0.06 inch) slice thickness and 1 mm (0.04 inch) slice indexing on System L. Figure 3.4-3 is a 3D image of the crack, PID #120. The data was obtained from 60 slices taken at 410 kV with 0.125 mm (0.005 inch) slice thickness on System J. Figure 3.4-4 shows a steel pipe coupler, PID #502, that was scanned on System I with 22 slices and 3 mm (0.12 inch) slice spacing. The aspect ratio of this part is slightly distorted in the display.

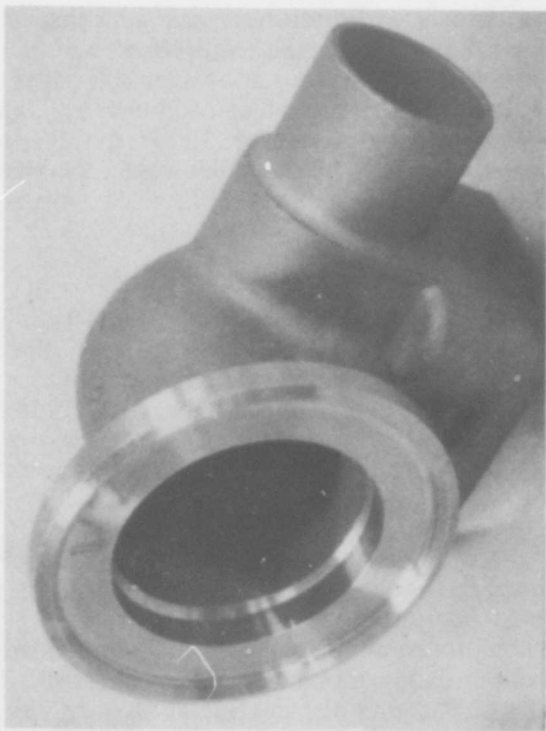
(a) Photo of PID #502

(b) Film X-ray of PID #502

(c) 3D view 1 of PID #502

(d) 3D view 2 of PID #502, rotated 60°

Figure 3.4-4 PID #502, steel elbow casting

Volumetric data sets can be obtained by taking contiguous CT slices along the axis of the casting that is being inspected. Data sets of this type have been created for PID #119 (shrinkage), PID #118A (holes), PID #120 (crack) and PID #502 (pipe coupler). Display of these images on a three-dimensional (3D) imaging system is useful for visualizing and understanding defect features. The 3D images shown in this report were created on a PIXAR image processing system.

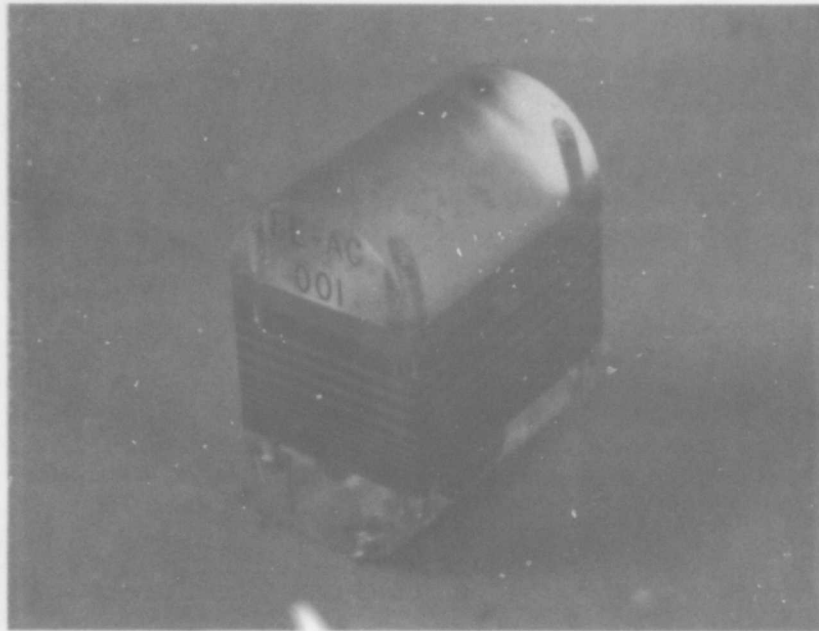
Figure C1-1 Photo of resolution phantom

The entire assembly is bolted together and the line pair plates can be changed if additional or a different range of line pairs is desired. Following CT scanning the reconstructed image is analyzed by measuring the modulation of the CT numbers resulting from a trace across the line pairs. The modulation at each line pair set is measured as a percentage of the modulation, where the modulation measured between the 3 mm (0.12 in) thick metal reference bar and 3 mm (0.12 in) thick acrylic steps is 100 percent. Operating parameters such as field of view, slice thickness, integration time and detector collimation will affect the results. It is desirable to obtain data at CT machine parameters that are the same as that used for part scanning. The resolution phantom has been fabricated in two forms, steel/acrylic and aluminum/acrylic. The steel/acrylic phantom is for systems of 300 kVp and up, the aluminum/acrylic phantom is for systems under 300 kVp.
